Use this kit to repair or replace the seals around your top. It contains sufficient material to reseal one top around the back edges and across the windshield.

## Kit Instructions

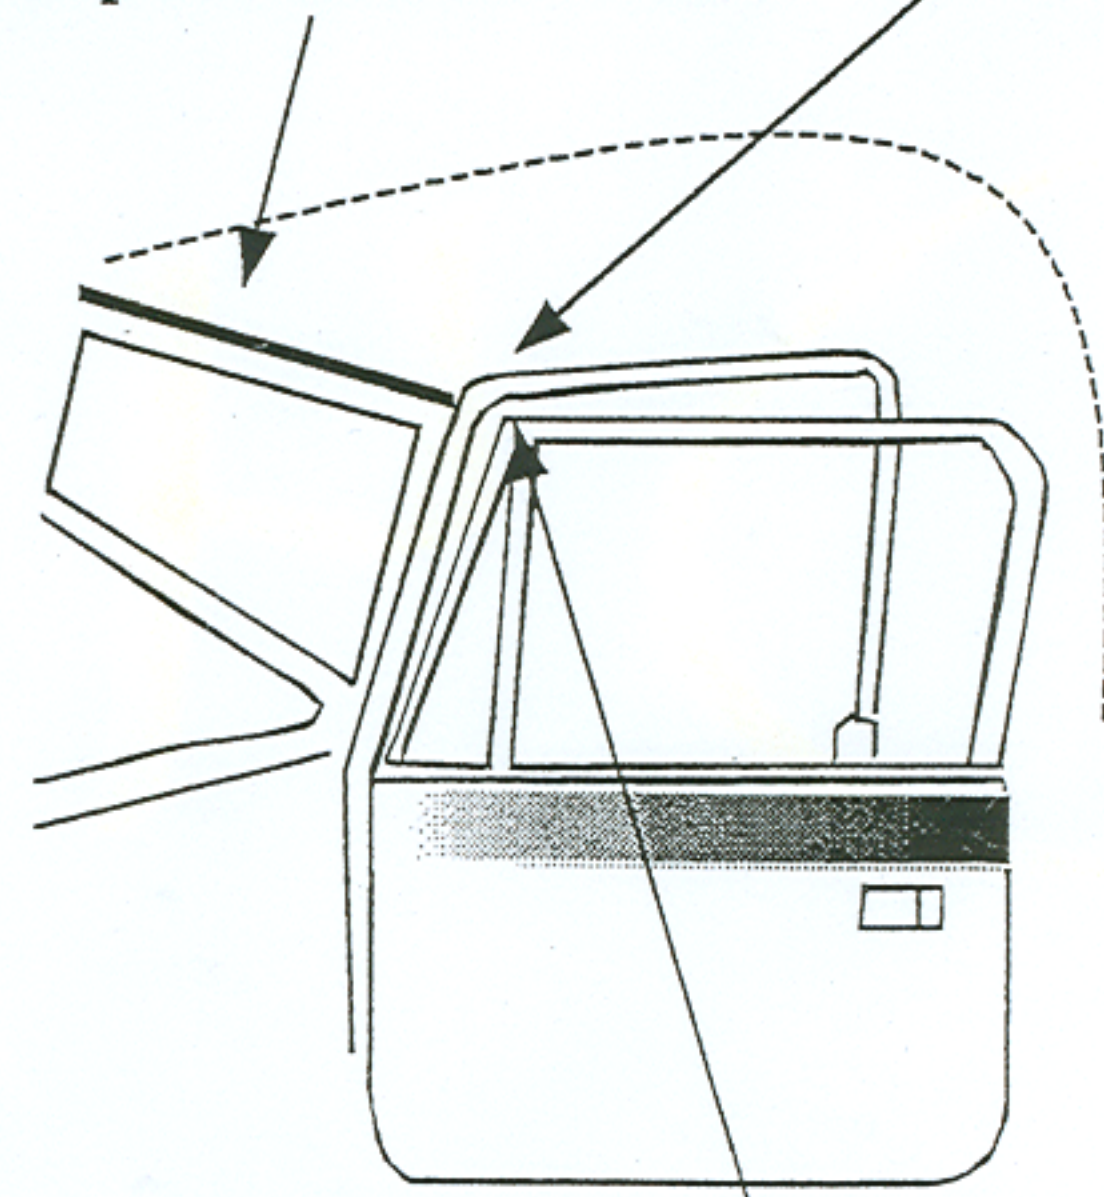
Hardtop to windshield frame seal.

- On Wrangler YJ units, make sure the small rubber corner finger (the small rubber molding at the upper corner of the door/windshield) is not folded under when you install your top. Installing this molding improperly causes wind noise.
- As door hinges wear, it tends to create a gap in the door seal at this point (upper corner of top/windshield). This can also cause wind noise and you may still think it's the top seal. You may need to shim or realign your doors to help this problem. See diagram below.

Check the top gasket's fit in this corner in CJ and YJ models. Make sure it's not bunched and in good condition. If not, add some extra left over 3/4" gasket material to the corners or use silicone caulk to reform a new gasket, then add the Seal Kit seal.
