RUBICON FRONT BUMPER

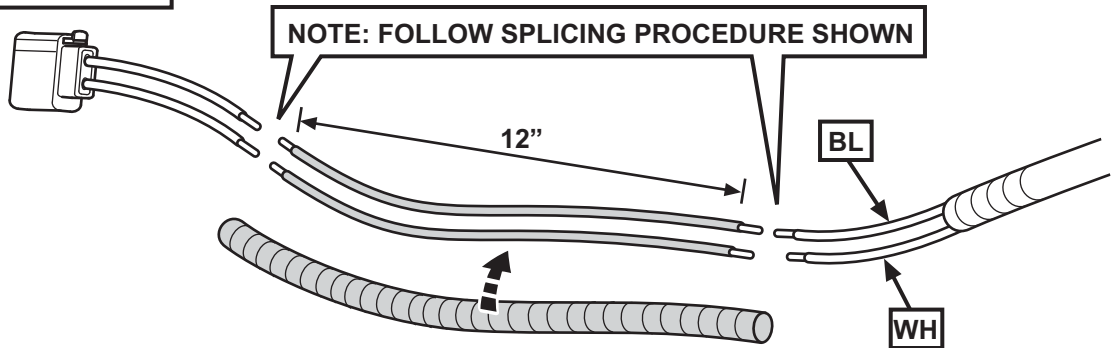
4

FOG LAMP WIRE EXTENSION

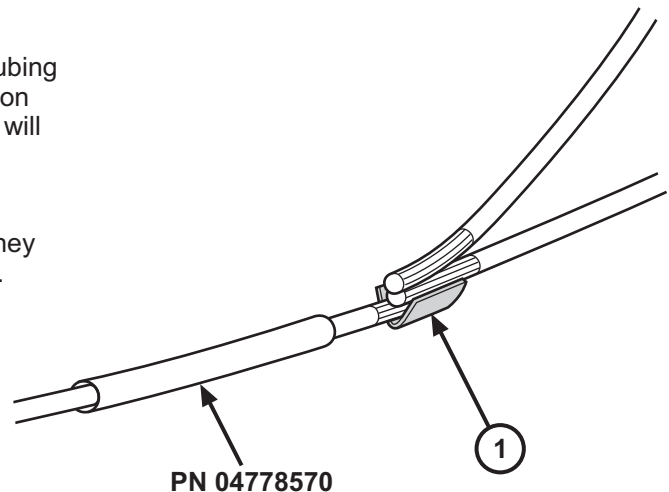
1. Remove 13 millimeters (0.50 inch) of insulation from each wire that needs to be spliced.
2. Place a piece of adhesive sealant-lined heat shrink tubing (Part Number 04778570 or equivalent) over the wire on one side of the splice. Be certain the length of tubing will be sufficient to cover and seal the entire repair area.
3. Place the strands of the wires being spliced so that they are overlapping each other within the splice band (1).

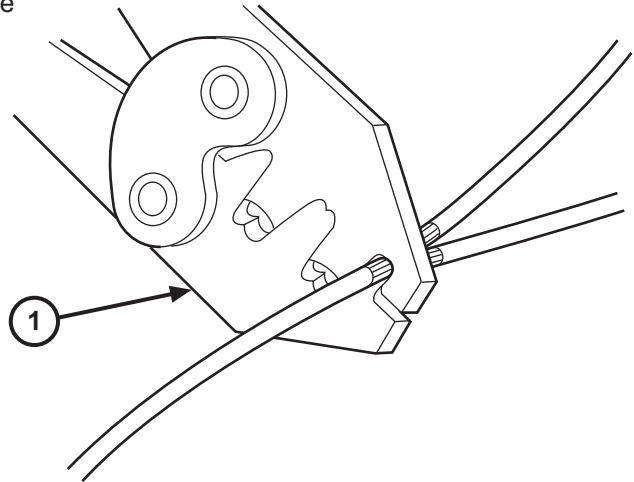
4. Using a crimping tool (1) (MOPAR Part Number 05019912AA, Miller Special Tool Number or equivalent) crimp the splice band and wires together securely.

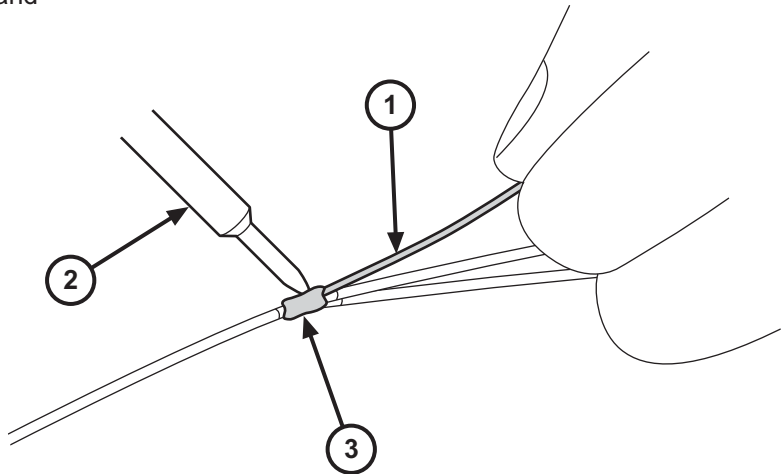
5. Using Rosin Core type solder (1) only and a suitable soldering iron (2), solder the wire and splice band connection (3) together.

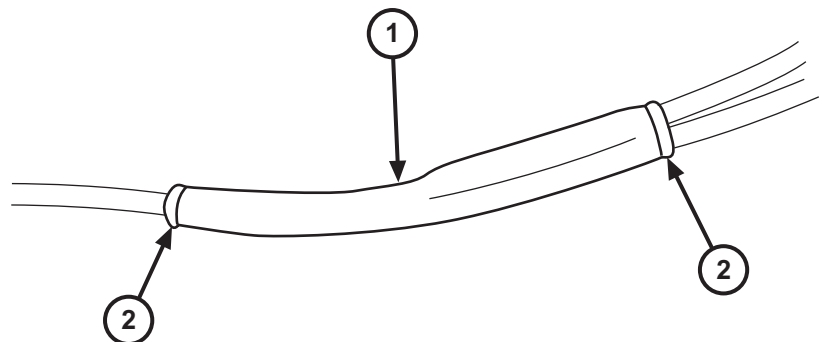
6. Center the heat shrink tubing (1) over the splice joint repair and heat using a suitable heat gun. Heat the joint until the tubing is tightly sealed and sealant (2) begins to ooze out of both ends of the tubing.

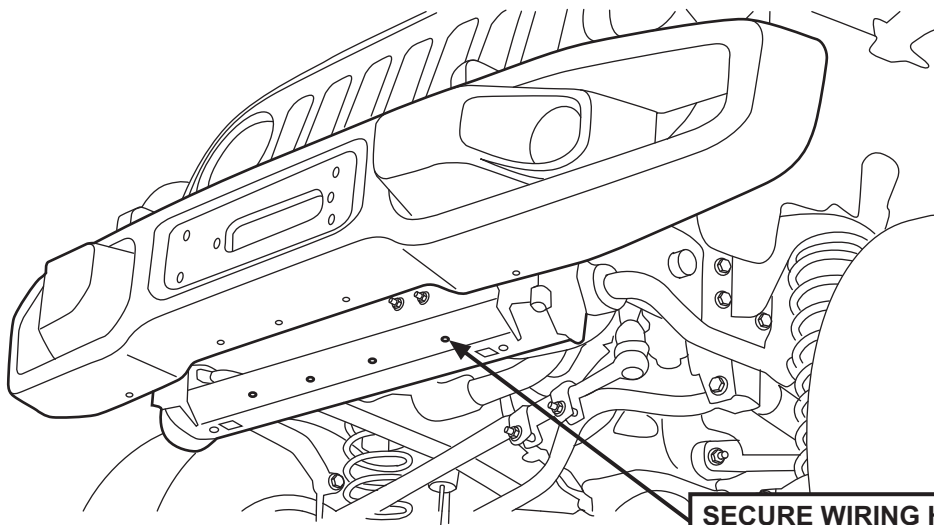
8

SECURE WIRING HARNESS CLIPS TO HOLES INSIDE BEAM
