RUBICON MANUFACTURING INC. 3290 MONIER CIR., RANCHO CORDOVA, CA. 95742 916-473-4600

INSTALLATION INSTRUCTIONS FOR: RE6010 XJ 3.5" SUPER-FLEX SUSPENSION LIFT W/ REAR ADD-A-LEAFS

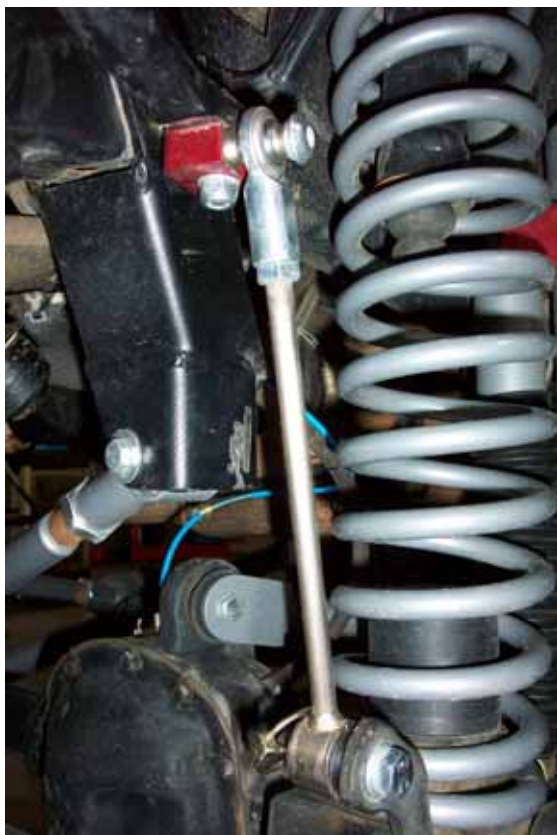
< FRAME END (RUBBER) - PHOTO 1 - AXLE END (ZERK ON TOP)>

10. Remove the factory lower control arms that are to be replaced.
11. Install the lower control arms with the rubber bushing at the frame (use factory bolt at this end, and don't fully tighten until vehicle is back on the ground). The super-flex assembly bolts to axle bracket with supplied hardware. The offset tube is to be located as low as possible (see photo 1).
