RUBICON MANUFACTURING INC. 3290 MONIER CIR., RANCHO CORDOVA, CA. 95742 916-473-4600

INSTALLATION INSTRUCTIONS FOR: RE7030 2" TJ/LJ BUDGET BOOST SUSPENSION LIFT

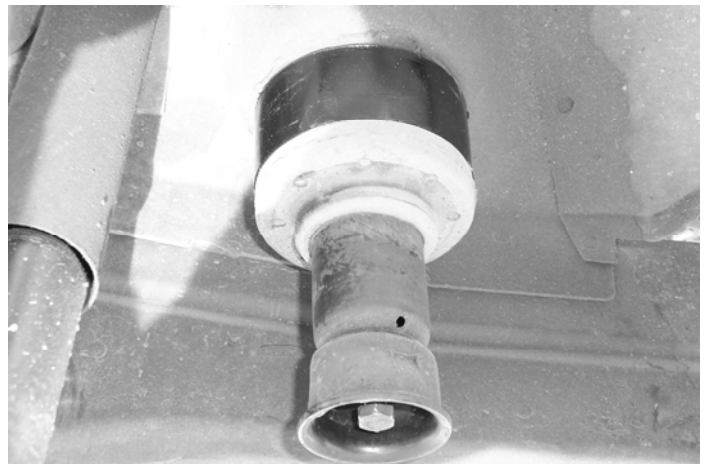
PHOTO 1

1. Support vehicle by the frame and axle.
2. Remove wheels, shock absorbers, and sway bar end links from the sway bar end only.
3. Remove rear factory coils.
4. Remove rear factory coil spring isolators.
5. Install coil spring spacers with raised lip side down (ref photo 1 for typical spacer installation). Install isolator with lip down.
6. Remove the rubber insert from the rear bump stop. Remove the bump stop cup. Place the bump stop extension spacer (RE1385) between the bump stop cup and the frame member using the supplied longer metric hardware (see photo 2).
6. Install rear coil springs.
7. Reconnect rear sway bar end links.
